Review of Design Criteria and Performance of Block Pavements in Gauteng

Author: A T Visser

TECHNICAL PAPER - DESIGN CRITERIA

REVIEW OF DESIGN CRITERIA AND PERFORMANCE OF BLOCK PAVEMENTS IN GAUTENG

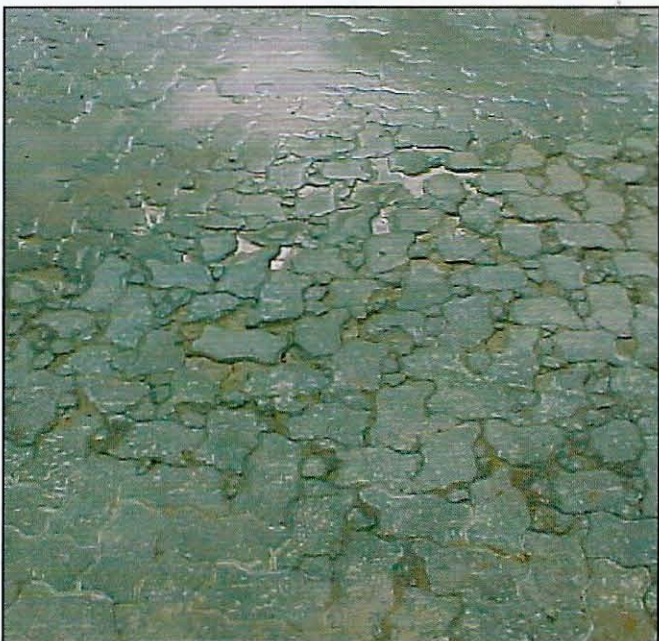
The Belle Ombre bus terminal is about 12 years old, was built with 80 mm G-blocks and it was estimated to have carried about 3 million E80s. At a location where severe turning movements take place there are signs of block breakage and poor drainage. This is shown in Figure 3. The DCP results at this location showed that the in-situ CBR to a depth of 170 mm below the sand was 28 or less, and to a depth of 420 mm was 10. It is not clear whether the deformation and soaking occurred because of the weak material, or whether the weak material resulted from the soaking. However, it is clear that the material at this location was substandard as the G5 classification is based on a soaked laboratory CBR. The large deformations then resulted in the blocks breaking. The locations, which performed well, fulfilled the structural design requirements.

Figure 3. Deteriorated block paving at Belle Ombre bus depot

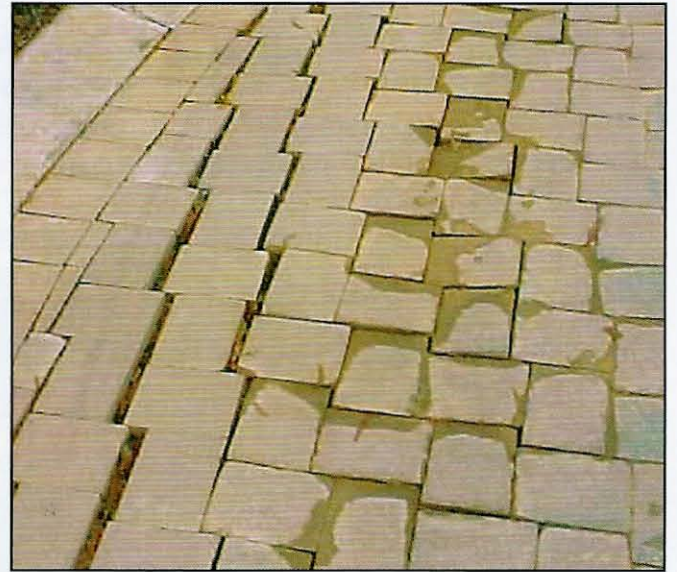
The last site with a granular subbase that was evaluated was the Tuscany Office Park. This facility was 4 years old, was constructed with 60 mm Cottage Stone pavers (type S-C or non-interlocking pavers) and has carried less than 0.1 million E80. Visually this is by far the worst site, as drainage problems, major deformation, heave and loss of jointing sand was found over most of the site as may be seen in Figure 4. This is attributed to the loss of jointing sand due to the base movement and aggravated by the type S-C paver. Similar experience with this type of paver has been found at other sites and all have started with poor support conditions or the use of this type of paver for relatively heavy traffic. The size and shape of the pavers also facilitate pumping of the bedding and jointing sand, which leads to loss of integrity and low spots where ponding water accelerates the deterioration. Unlike the fully interlocking paving blocks, Cottage Stone type "S-C" are unforgiving, in that any weakness, whether by design or construction, in the underlying layers, will lead to rapid unwanted deterioration. A lack of maintenance was contributing to the deterioration, as in some areas the pavement structure was adequate as determined from the in-situ CBR. However, in areas where the upper 300 mm of the granular material had an in-situ CBR of less than 10, the deterioration was more severe.

Figure 4. Badly deteriorated block pavement on weak structure

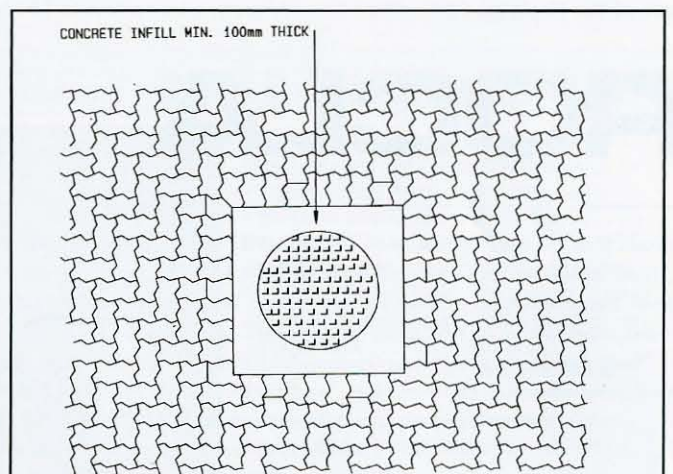
Another problem, which has been noticed, is the detailing of the blocks both at the kerb and at manholes or drainage catchpits. Invariably the blocks at kerbs have to be cut to provide the correct pattern. Often cement grout is used to fill in the voids adjacent to the fixed structure. This grout tends to shrink and over time the pieces break out under the action of climate, water flow and traffic, leaving a void. This then becomes a perfect place for water ingress into the underlying layers. The solution to this problem is to use a gutter shape where the water flow is in the gutter. Blocks are placed slightly above the level of the gutter to ensure drainage even when there is settlement of the pavement structure. This should also be standard practice at catchpits. In addition, since drainage catchpits are at a low point, there should be 25 mm diameter drainage holes at the top of the subbase level the same manner as at the kerbs. Catchpits and manhole covers should receive special attention and a reinforced concrete or

module should be placed as shown in Figure 6. Attempting to use blocks and grout has been shown to be completely ineffective for these situations.

Figure 6. Details at manholes or drainage catchpit (CMA, 1998)
