# **Durability of Reinforced Concrete Sewer Pipeline over 23 Years**

Authors: G E Blight<sup>1</sup> and M G Alexander<sup>2</sup>

ABSTRACT: A reinforced concrete sewer pipeline in Johannesburg, South Africa, is exposed to the weather where it crosses three dry valleys over a series of pipe bridges. In 1975, a year after commissioning the sewer, it was discovered that the pipes were cracking, that the cracking was spreading on each affected pipe, and that more and more pipes were being affected.

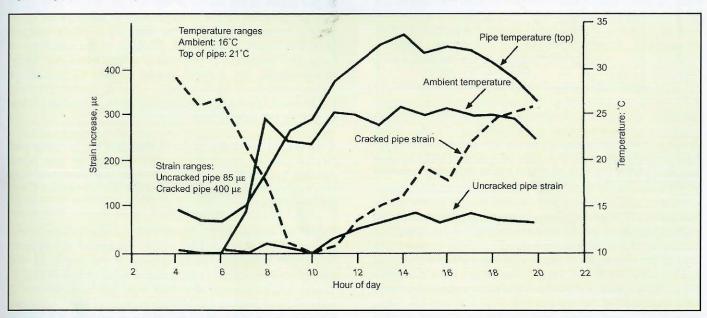
Fig. 4. Comparison of thermal strains measured on cracked and uncracked pipes

afternoon was 7-8°C above ambient temperature, and 5°C warmer than ambient in the early morning. The surface of an uncracked pipe expanded longitudinally as the temperature rose and contracted as it fell. In contrast, longitudinal movements measured across a crack showed a decrease at first as the uncracked concrete on either side of the crack expanded towards the crack, followed by an increase once the crack had closed and the whole top of the pipe expanded. Movements measured across a crack were much higher than those measured on an uncracked surface, as shown by Fig. 4, but this obviously depended on the distance between cracks.

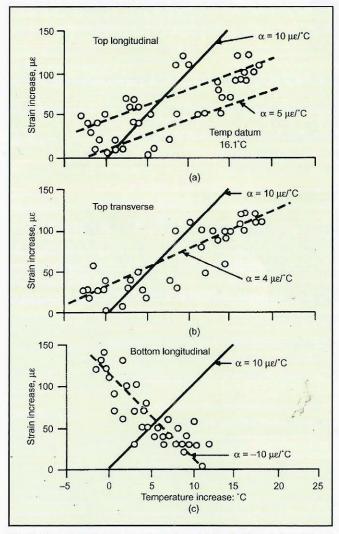
Fig. 5. Thermal strains measured on pipes: (a) longitudinal strains at top of pipe; (b) transverse strains at top of pipe; and (c) longitudinal movement (expressed as strain) across a transverse crack

At the time of measuring, this pipe was largely uncracked, but a circumferential crack did exist at mid-length of the pipe at the lower end of the vertical diameter. The strain targets were fixed at the mid-length of the pipe at the ends of the vertical and horizontal diameters. Longitudinal strains were measured at top, bottom, east and west positions and transverse strains were measured at the top position. Figs 5(a) and (b) show, respectively, longitudinal and transverse thermal strains

The fact that the effective coefficient of thermal expansion of the uncracked pipe surface (Figs 5(a) and (b)) was  $5\mu\epsilon/^{\circ}C$ , or about half of the coefficient of free expansion of reinforced concrete, showed that the pipe wall was being subjected to two-dimensional thermal bending. When the outer surface of the pipe wall was hotter than the inner surface, a compressive strain of  $5\mu\epsilon/^{\circ}C$  was induced in it while a tensile strain of  $5\mu\epsilon/^{\circ}C$  was induced at the inner surface. When the outer surface was colder than the inner surface, tension was caused at the outer surface and compression at the inner.

The failure strain of concrete in tension being 100-150με, whenever the difference in temperature between the inner and outer surfaces of the pipe exceeded about  $100/5 = 20^{\circ}$ C, cracking would have been initiated either at the inner or outer surface of the pipe. Because of the strain distribution, thermal bending on its own was unlikely to cause the pipes to leak as any crack passing right through the pipe wall would always be closed either at the inside or the outside. However, if sand and grit particles in the sewage were to lodge in an open crack in the invert of the pipe, the crack would remain wedged open and a leak could ensue. Because of the presence of hoop and longitudinal reinforcing which acted as strain concentrators, the thermal cracks tended to run either circumferentially or longitudinally — that is, thermal cracking would eventually have produced a uniform rectangular crack pattern on the pipe surface.

The strain targets at the bottom of the pipe straddled the circumferential crack and the 'strains' measured at this point (Fig. 5(c)) represent mainly closure of the crack as the temperature increased in the same way as shown in Fig. 4. These measurements are thus not real strains, but a summation of thermal movements in cracked and uncracked concrete accumulated over the distance between the pair of

targets, expressed in strain units. The negative slope of the trend line in Fig. 5(c) shows that crack closure as the temperature increased was the predominant component of the movement.

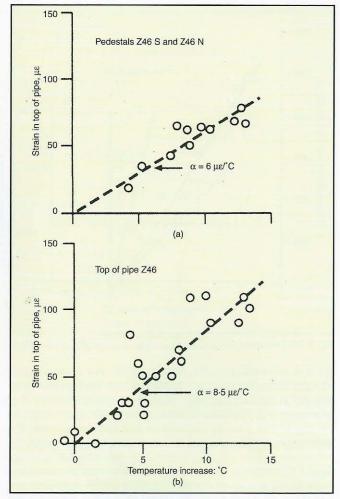
Figure 7(a) shows the movement of the two ends of pipe Z46

Fig. 7. Strain of pipe between supporting pedestals (a) compared with strain of top of pipe (b)

relative to its pedestals, expressed as a strain over the full length of the pipe. It can be seen from the figure that the performance of this pipe was close to expectation. Fig. 7(b) shows the corresponding relationship between the thermal expansion of pipe Z46 (top longitudinal gauge) and temperature. Adding the two effective coefficients of expansion gives a coefficient of expansion for the bridge deck between pedestals of 14.5με/°C which corresponds reasonably well with the data shown in Fig. 6.

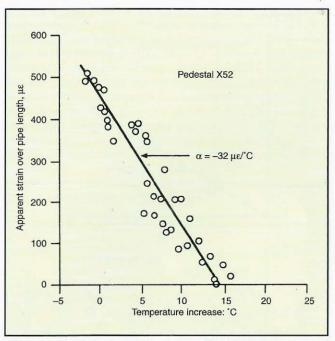
Other sets of measurements, however, were not so reassuring. The movements of another pipe relative to its pedestal are shown in Fig. 8. Movement was only measured at one end of the pipe, but the magnitude of the movement appears to indicate that some pipes were moving relative to the pedestals in 'trains' made up of several pipes. In this case the train appeared possibly to consist of  $32/6 \approx 5$  pipes. It was estimated that the pipe joints could only tolerate an opening movement of 15 mm before starting to leak. This amount of movement could occur at a single joint if a train of ten pipes moving as a unit were to be subjected to a temperature change of 40°C. This was very unlikely to happen, but was by no means impossible.

Fig. 8. Apparent strain of pipe relative to pedestal illustrating 'pipe train' effect

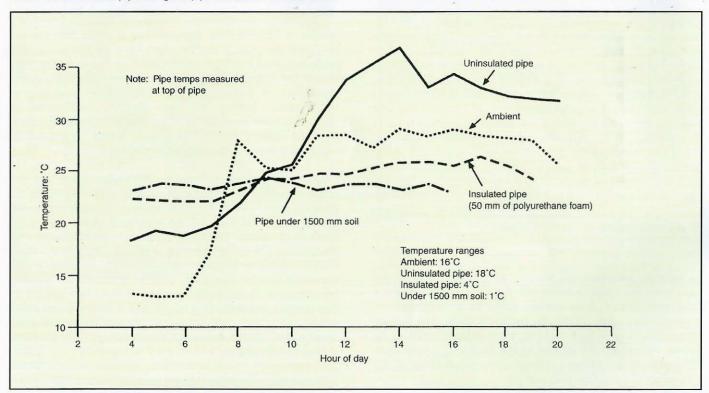
decided to investigate the efficacy of 50 mm thick sheet of 30 kg/m³ polyurethane foam, protected from the weather by an external aluminium cladding. Preliminary measurements (Fig. 9) showed that this system reduced the temperature range on the top of the pipe by a factor of 4·5 and approached the temperature protection provided by a generous soil cover.

Fig.9. Effect of insulating pipe on thermal strains

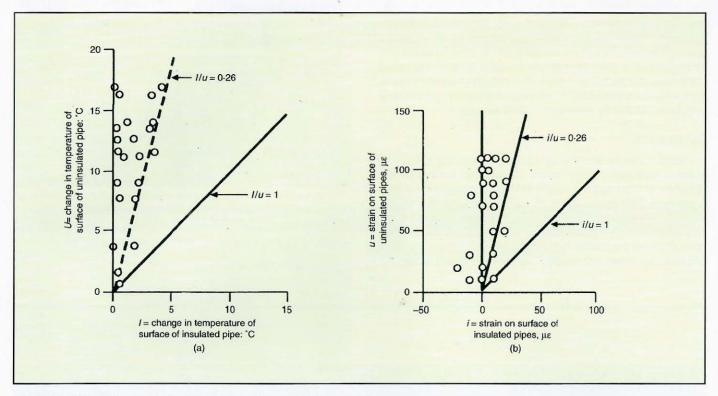
Figure 10 shows a direct comparison between temperatures and thermal strains on the surface of an unprotected pipe and that of two insulated pipes. Fig. 10(a) shows that the maximum

temperature range at the surface of an insulated pipe is only 0.26 of that at the surface of an unprotected pipe while Fig. 8(b) shows that thermal strains are similarly reduced by a factor of 0.26. This means that a maximum likely ambient temperature fluctuation of  $40^{\circ}\text{C}$  would produce a variation at the surface of an insulated pipe of only  $10^{\circ}\text{C}$  which, in turn, would induce tensile strains at the pipe surface of about  $50-60\mu\epsilon$ . Strain of this magnitude would be insufficient to initiate thermal cracks in intact concrete, but would still be sufficient to extend existing cracks. This conclusion is supported by the observation that before insulating the pipes, the average rate of crack extension (over a 75-day period) appeared to be 11 mm / day. After insulating the pipes, the rate of crack extension fell to 3 mm / day but crack extension did not stop.

Fig. 10. Effect of insulation on reducing: (a) pipe temperatures; and (b) thermal strains
