# Using Colloidal Silica to Protect Concrete from BSA in Wastewater & Organic Waste Environments

*Biogenic sulfuric acid attack — mechanisms, field evidence, and a colloidal silica mitigation strategy*

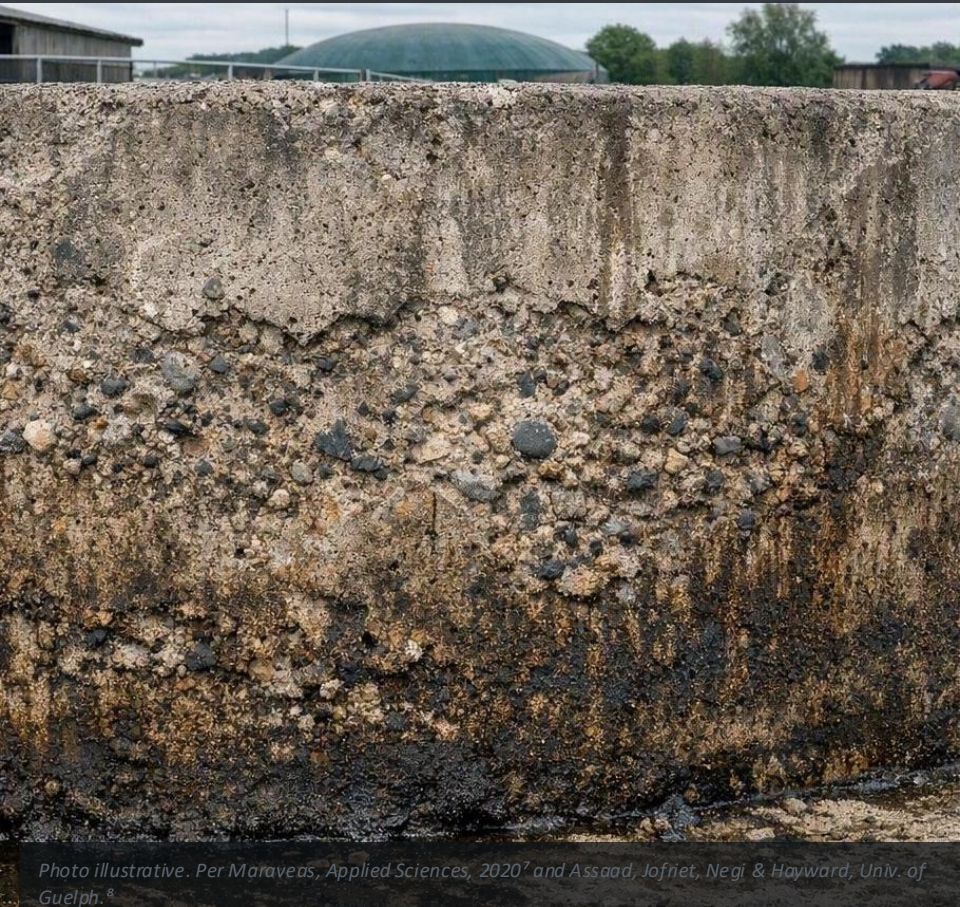
*Photo illustrative. Per Maraveas, Applied Sciences, 2020<sup>7</sup> and Assaad, Jofriet, Negi & Hayward, Univ. of Guelph.<sup>8</sup>*

## Slurry stores, manure tanks & barn floors

Stored manure and silage effluent release hydrogen sulfide, ammonia, and sulfates that attack tanks, channels, and slatted floors.

- Poultry, cattle, and swine manure all carry corrosion-inducing chemicals.
- $\text{H}_2\text{S}$  is identified as the most aggressive agent in farm structures.
- High water-cement ratio (e.g. 0.50) markedly worsens durability.

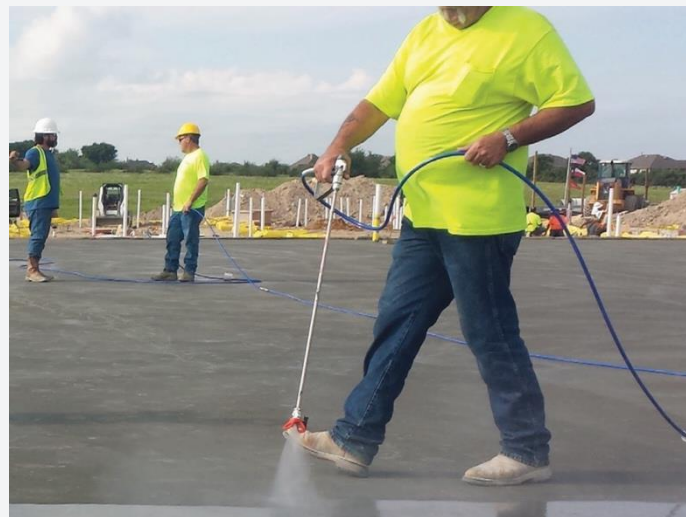
*Colloidal silica applied to a concrete surface*

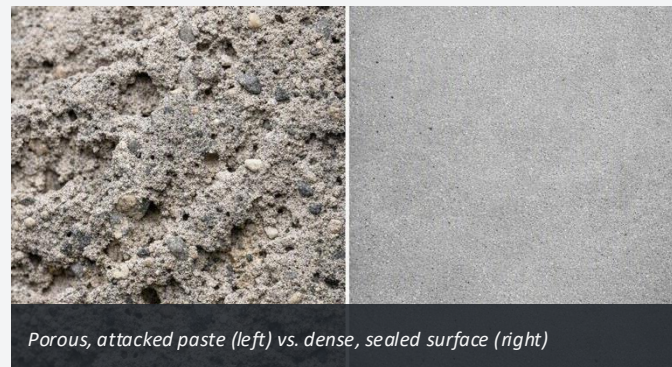
## 2. Pore refinement

Nano-particles and new C-S-H fill capillary voids, refining pore size and cutting permeability. Less connected porosity means acid and sulfate have no easy route inward.<sup>10,11</sup>

*Porous, attacked paste (left) vs. dense, sealed surface (right)*

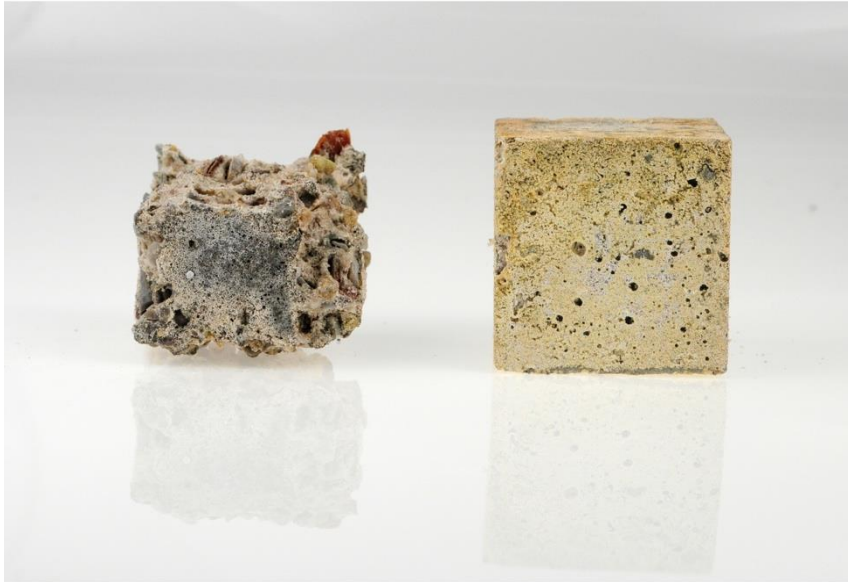
1 hour

# 31% Hydrochloric Acid Testing
