Concrete Cover to Reinforcement – or Cover-up

Author: A Neville

TECHNICAL PAPER

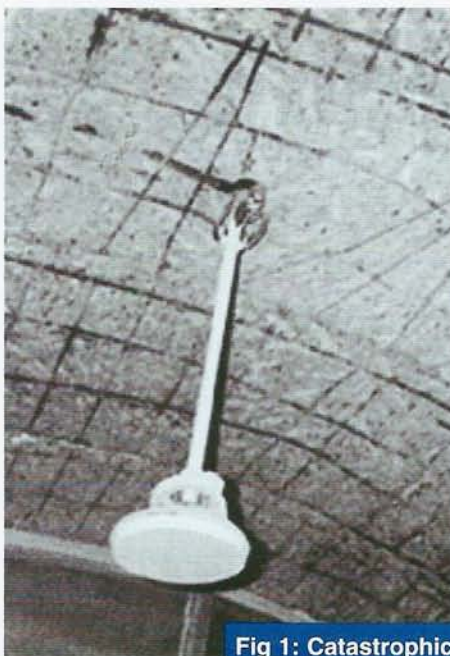
Fig 1: Catastrophic delamination of soffit of a slab due to inadequate cover for extreme exposure conditions

What is considered adequate cover is prescribed in design codes. Many codes in more-or-less temperate climates underestimate the fact that in some other climates the severity of exposure can be much more acute than what is labelled "very severe" in Great Britain or in many parts of the United States. The Middle East, and especially the Gulf area, is a prime example of truly extreme conditions. Here, the temperature of the concrete is high and the insolation is severe, so that a considerable depth of concrete becomes very dry and "thirsty". At some later stage, the seawater, carried by wind in the form of droplets or aerosol, or salt-laden dust, wetted by dew, is deposited on the surface of the concrete and imbibed to a considerable depth. The process is cumulative and chloride ions reach the surface of the reinforcement (Fig. 1). The irregularly placed reinforcing is now visible.

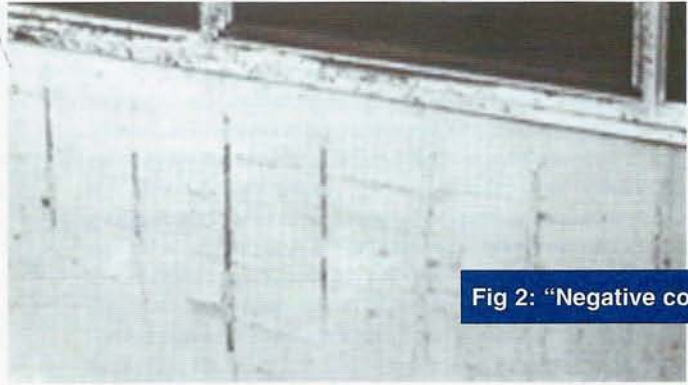
Fig 2: "Negative cover"

In passing, I could add that the members, some of which had a negative cover, were cladding units without interior lining, 75 mm (3 in.) thick. The reinforcing bars were 25 mm (1 in.) in diameter, with a specified cover, front and back of 20 mm (¾ in.). Can this be achieved in real life? What happened in the event is that chloride ingress occurred from outside and carbonation from inside the building. This must be the classical case of reinforcement suffering from the worst of both worlds. Those familiar with construction may wonder how woefully improper cover can exist, given that, on most well-regulated sites, the position and fixing of reinforcement is checked by the engineer, or his representative, prior to authorization of the actual concreting. There is a delightful story, I am assured not

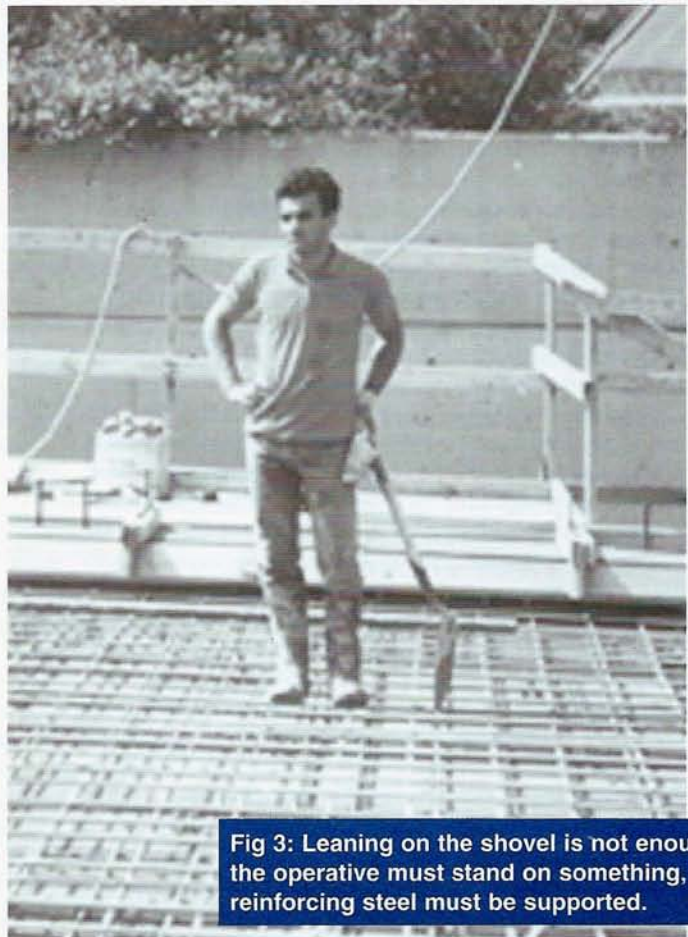
Fig 3: Leaning on the shovel is not enough; the operative must stand on something, and reinforcing steel must be supported.
